LPC# 0430305282--DuPage County  
Downers Grove/Ellsworth Industrial Park  
ILN 000508246  
SF/HRS

# CERCLA

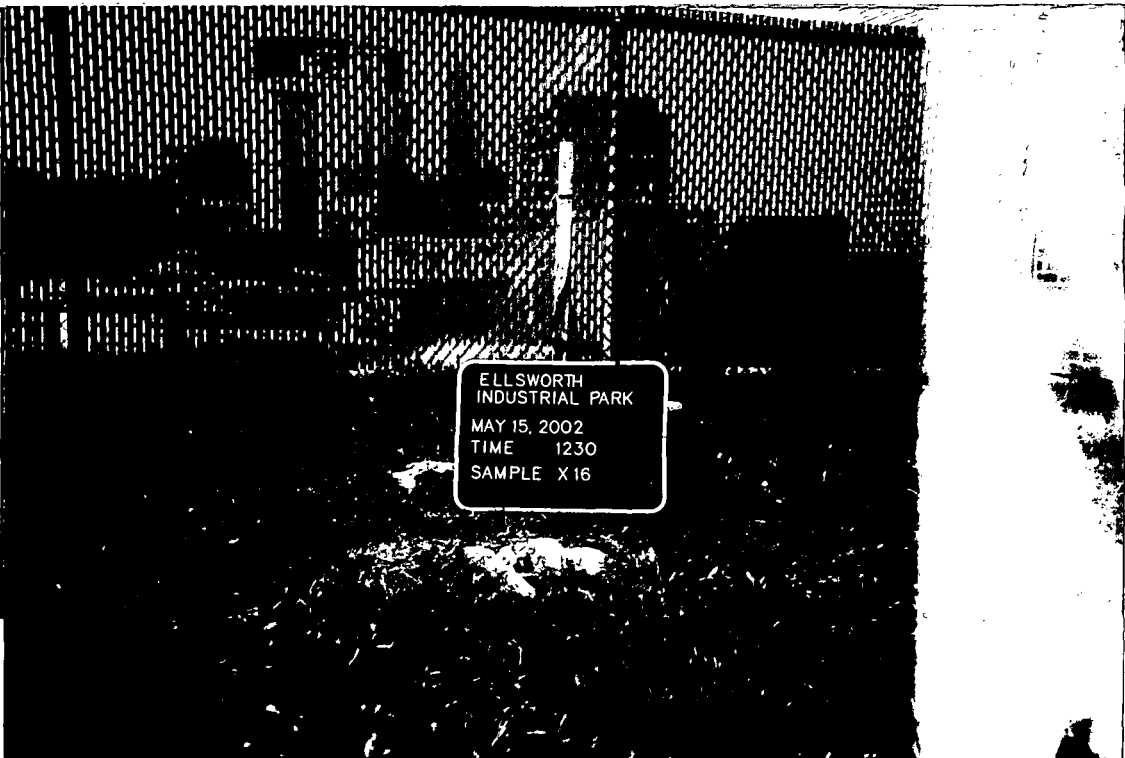
**COMMENTS:** Photo of  
soil sample location X-16,  
collected from probe  
location GP-16. Located  
west of the southwest corner  
of the Arrow Gear Co.  
facility located at  
2301 Curtiss Street.

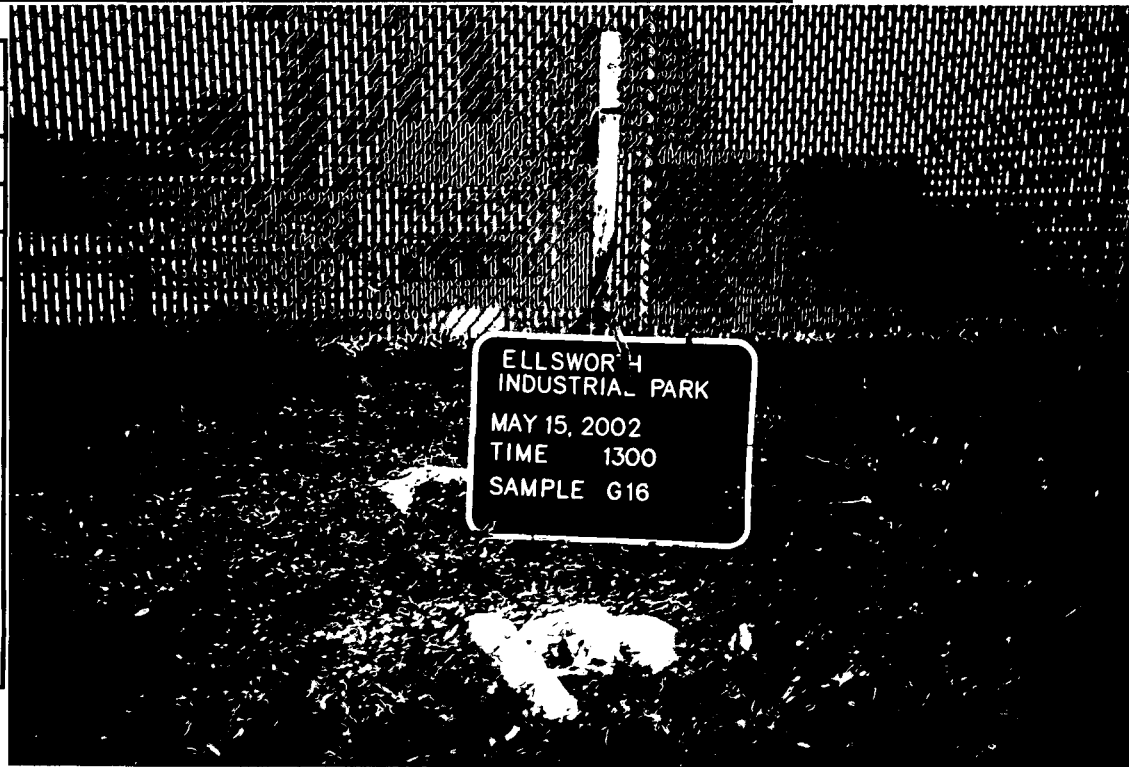
**COMMENTS:** Photo of groundwater sample location G-16, collected from probe location GP-16. Located west of the southwest corner of the Arrow Gear Co. facility located at 2301 Curtiss Street.

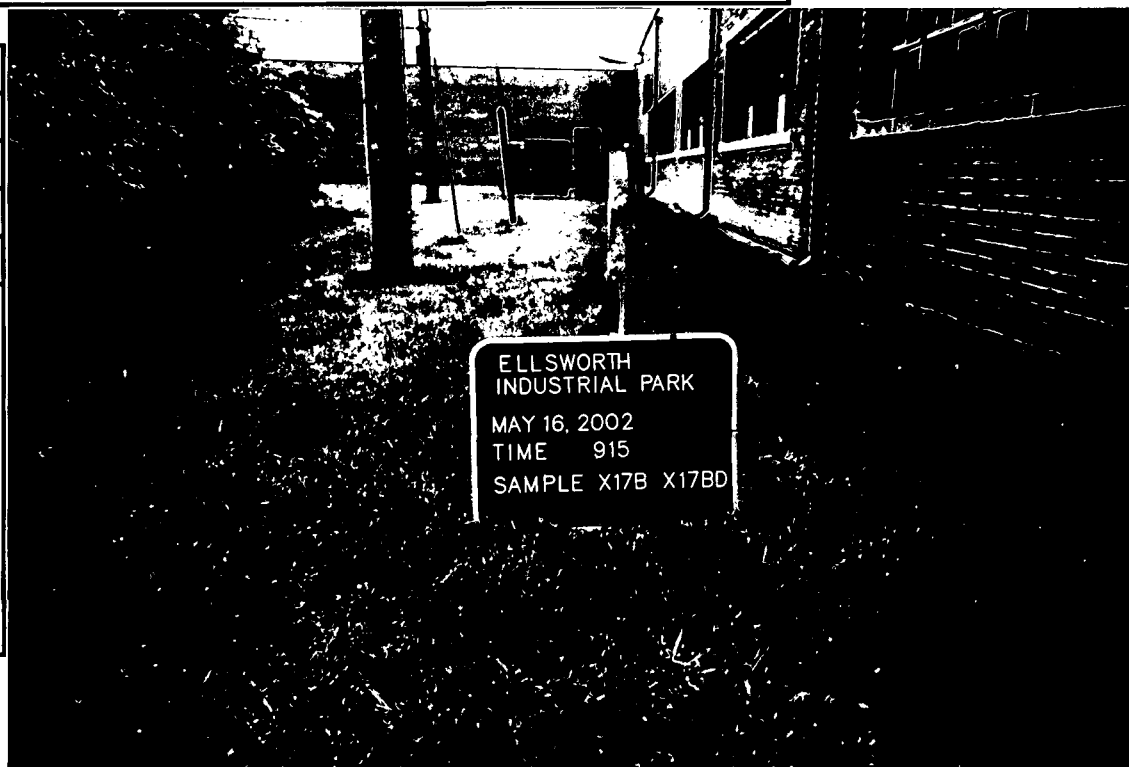
**COMMENTS:** Photo of soil sample location X-17B and X-17BD, collected from probe location GP-17. Located south of the Arrow Gear Co. facility located at 2301 Curtiss Street.

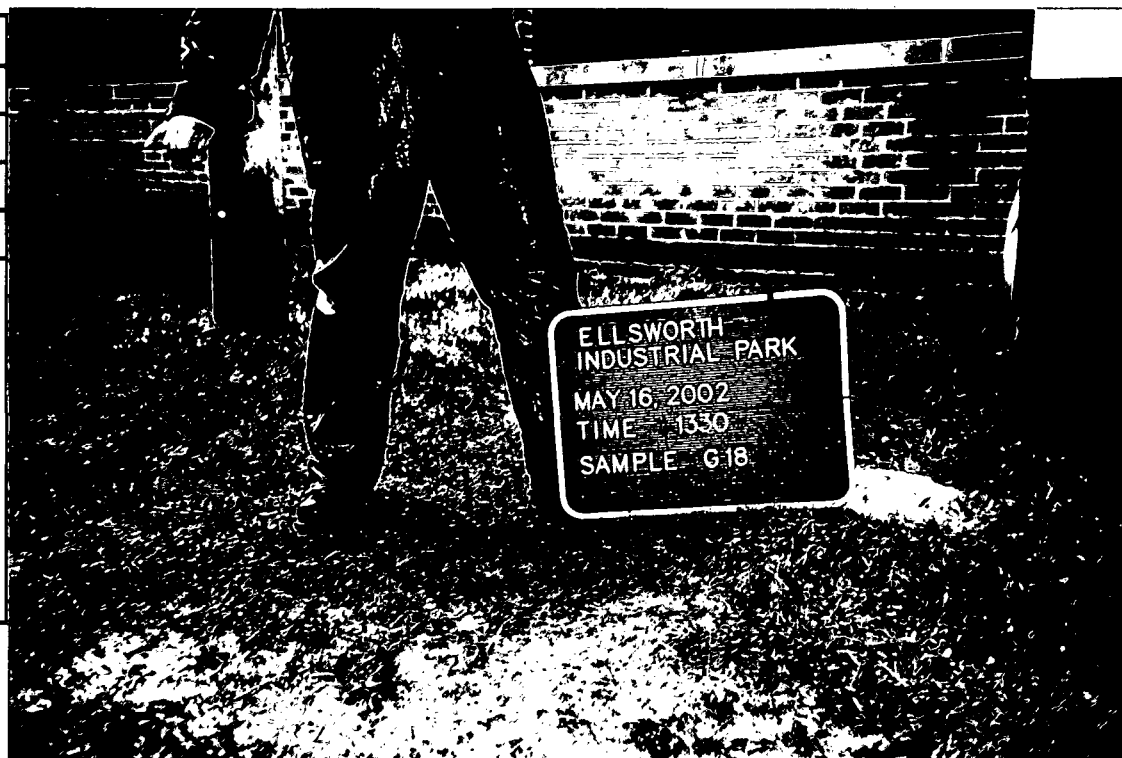
**COMMENTS:** Photo of groundwater sample location G-18, collected from probe location GP-18. Located south of the Arrow Gear Co. facility located at 2301 Curtiss Street.

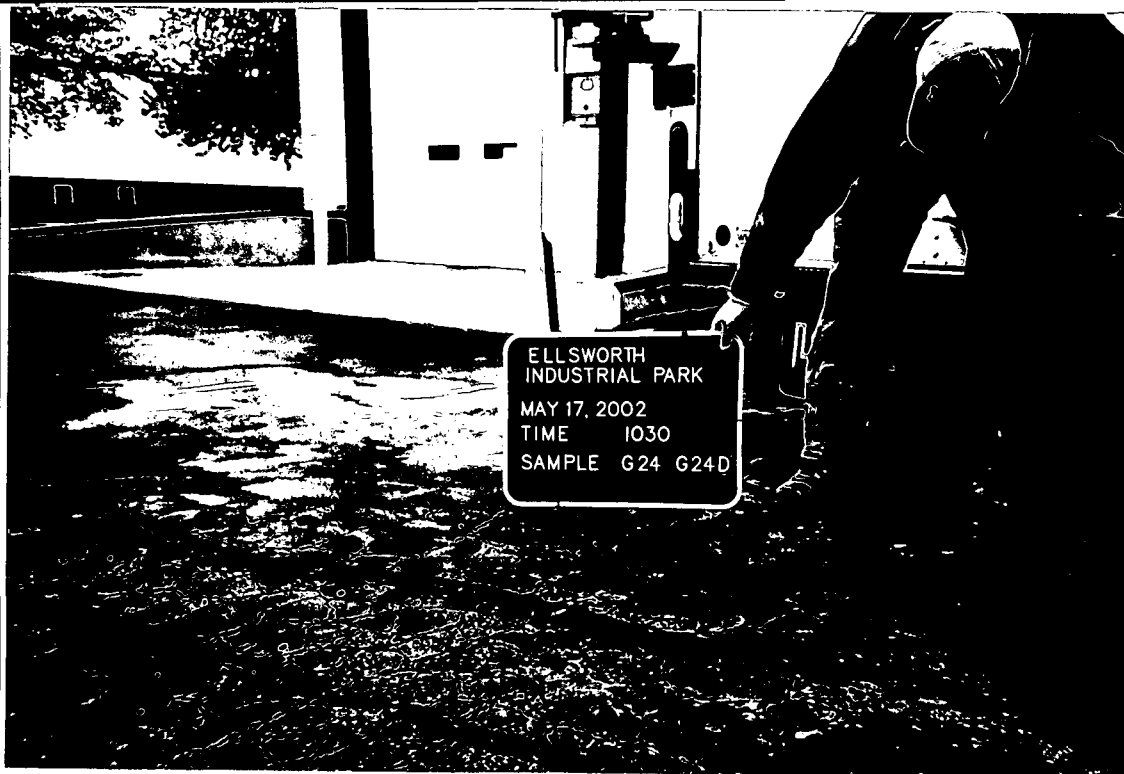
**COMMENTS:** Photo of groundwater sample location G-24 and G-24D, collected from probe location GP-24. Located south of the Precision Brand facility near the southern loading dock area at 2250 Curtiss Street.

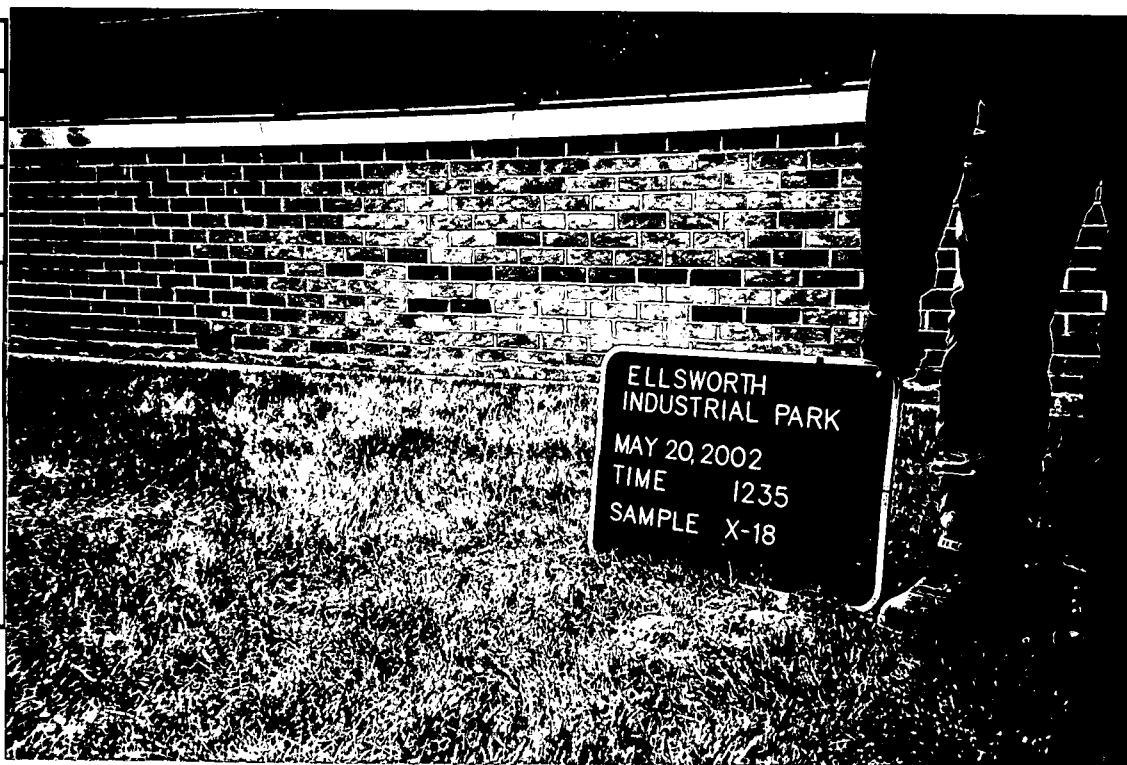
**COMMENTS:** Photo of soil sample location X-18, collected from probe location GP-18. Located south of the Arrow Gear Co. facility located at 2301 Curtiss Street.

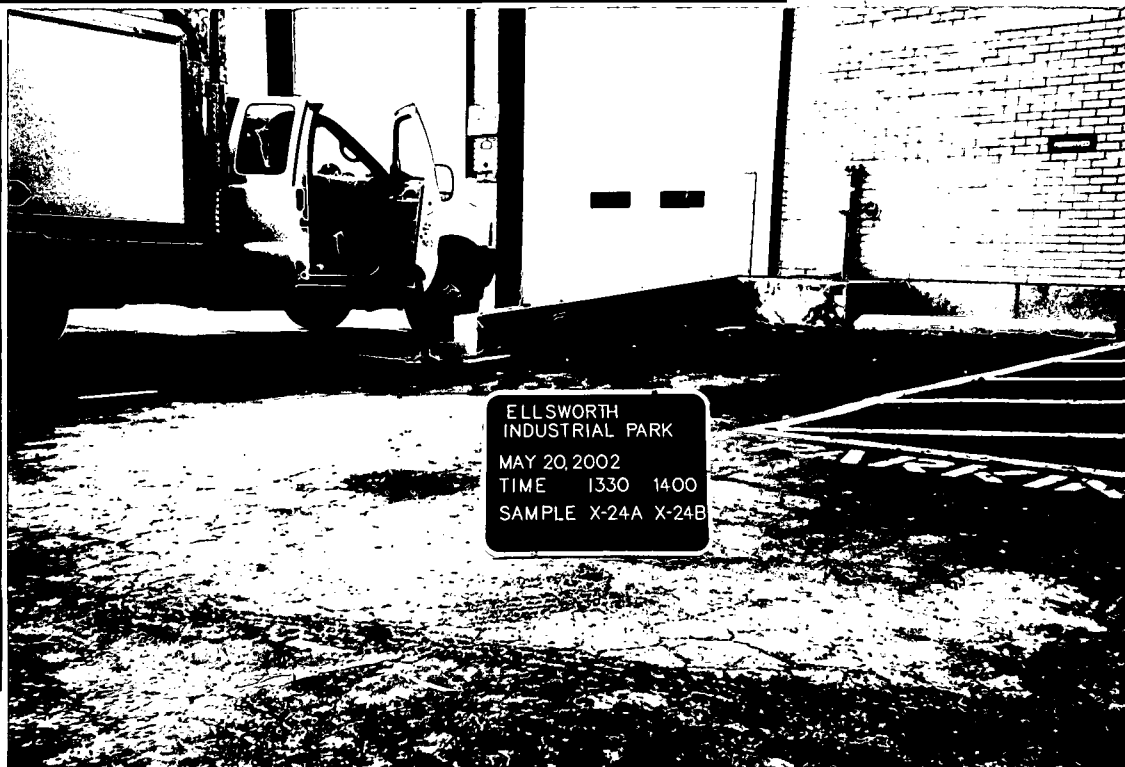
**COMMENTS:** Photo of soil sample location X-24A and X-24B, collected from probe location GP-24. Located south of the Precision Brand facility near the southern loading dock area at 2250 Curtiss Street.

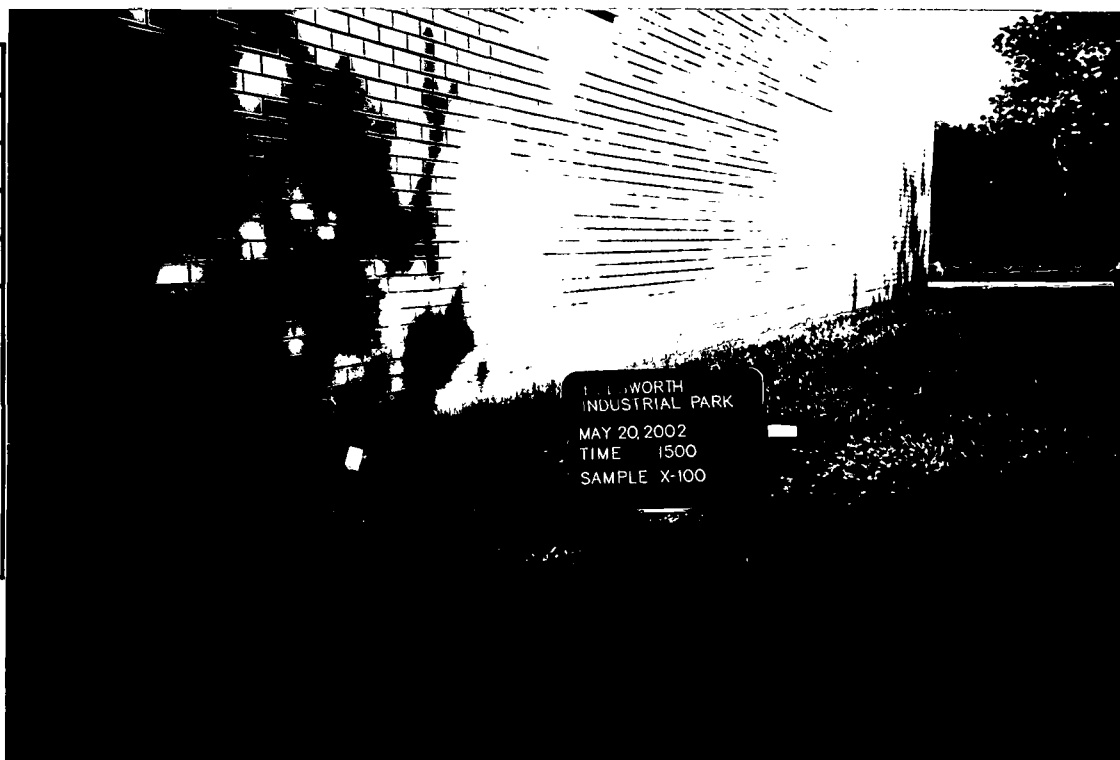
**COMMENTS:** Photo of soil sample location X-100, collected from a stressed vegetation area west of the Precision Brand facility at 2250 Curtiss Street.

Soil contamination has been documented at the EIP at concentrations above observed release criteria (Table 6). With the exception of soil sample X-100 collected from Area 3, the

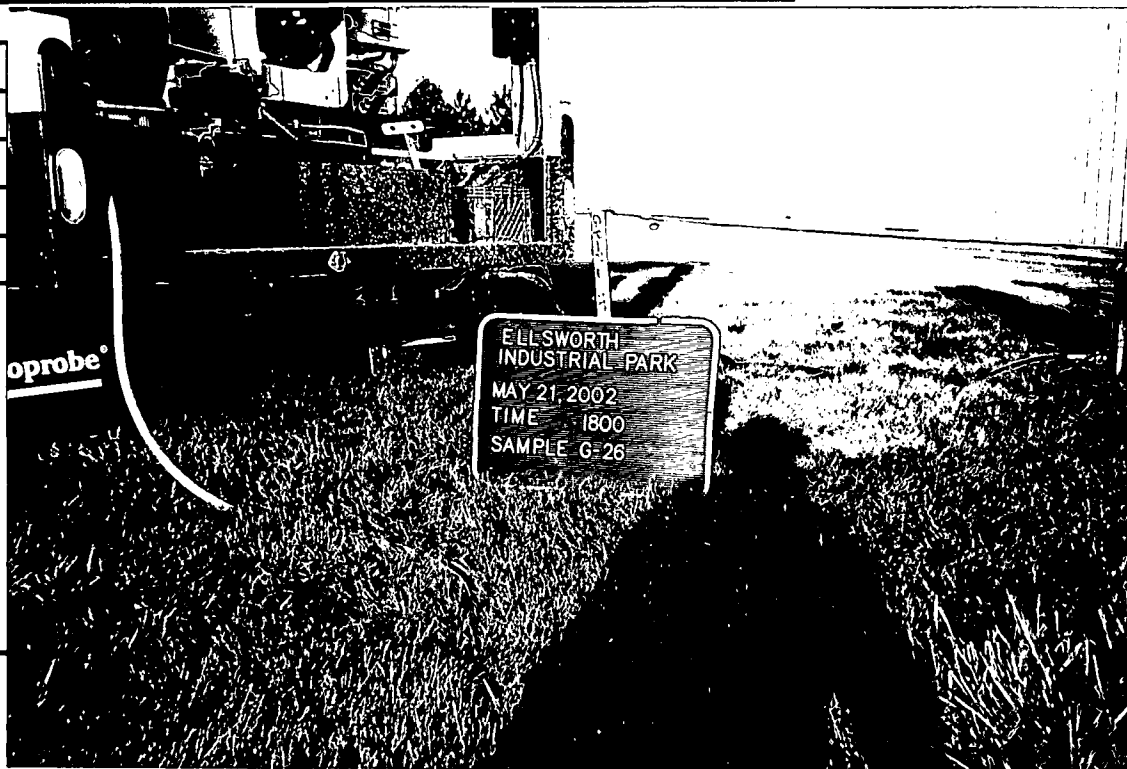
**COMMENTS:** Photo of groundwater sample location G-26, collected from probe location GP-26. Located north of the Precision Brand facility at 2250 Curtiss Street.

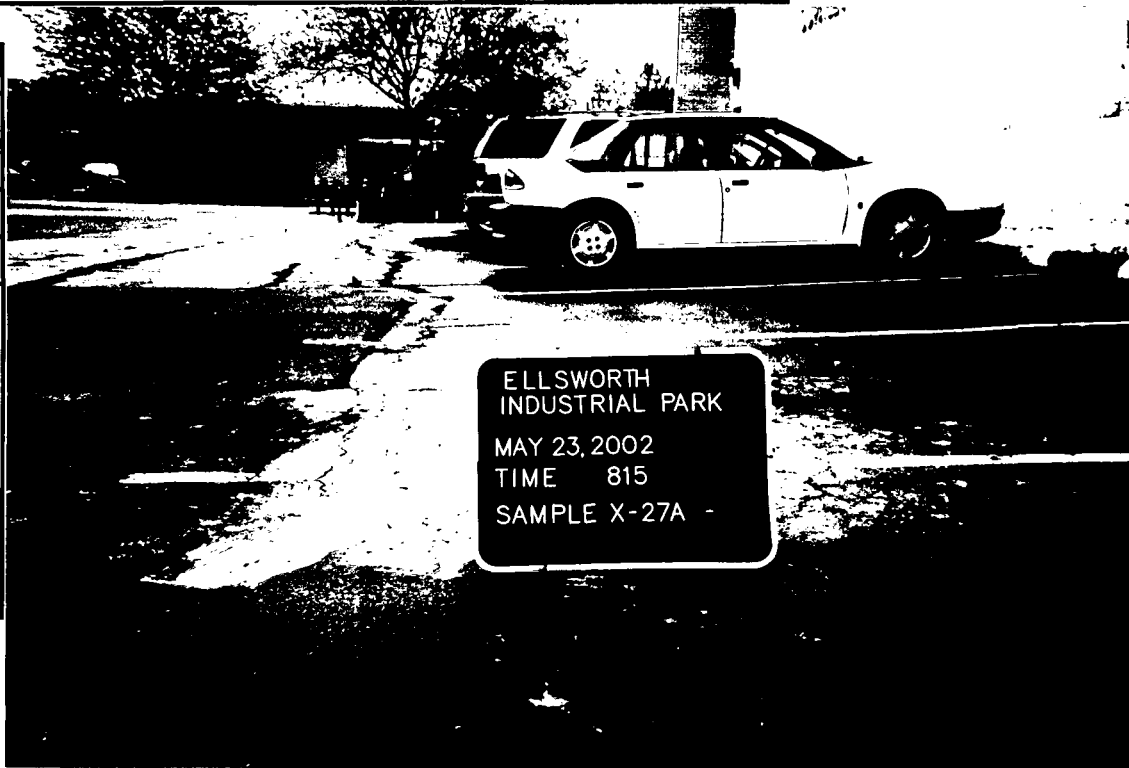
**COMMENTS:** Photo of soil sample location X-27A, collected from probe location GP-27. Located in the east parking lot of the Precision Brand facility at 2250 Curtiss Street.

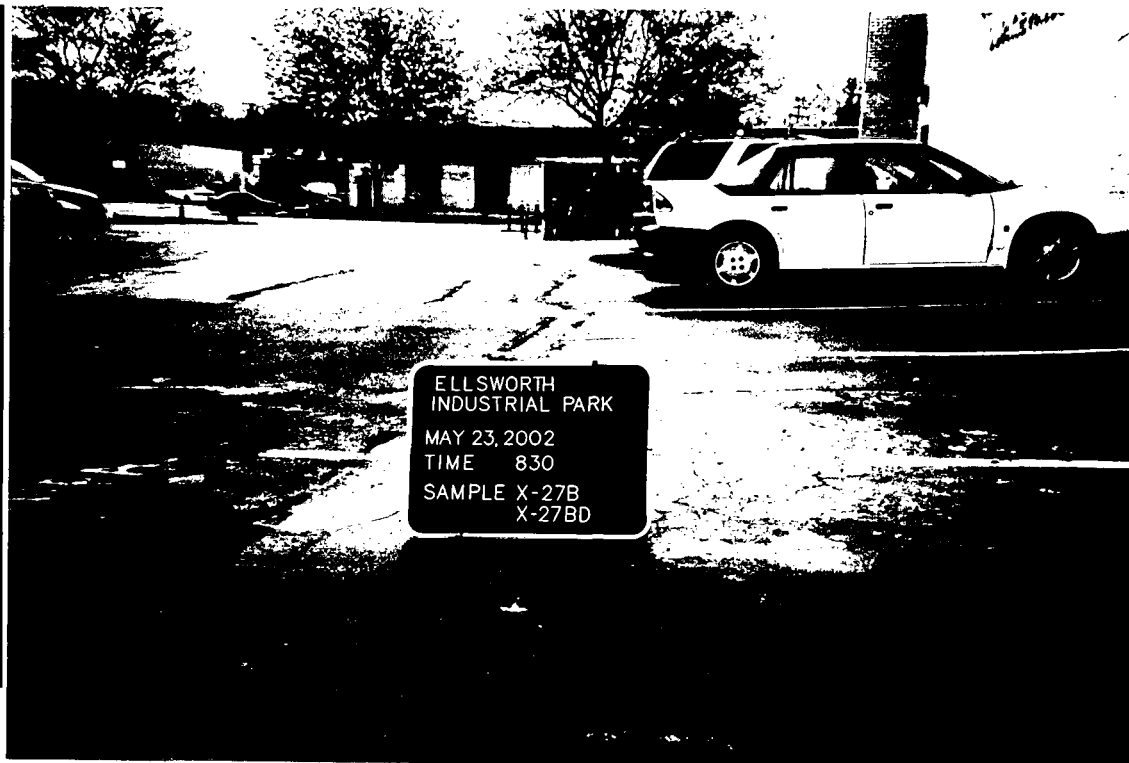
**COMMENTS:** Photo of soil sample location X-27B and X-27BD, collected from probe location GP-27. Located in the east parking lot of the Precision Brand facility at 2250 Curtiss Street.

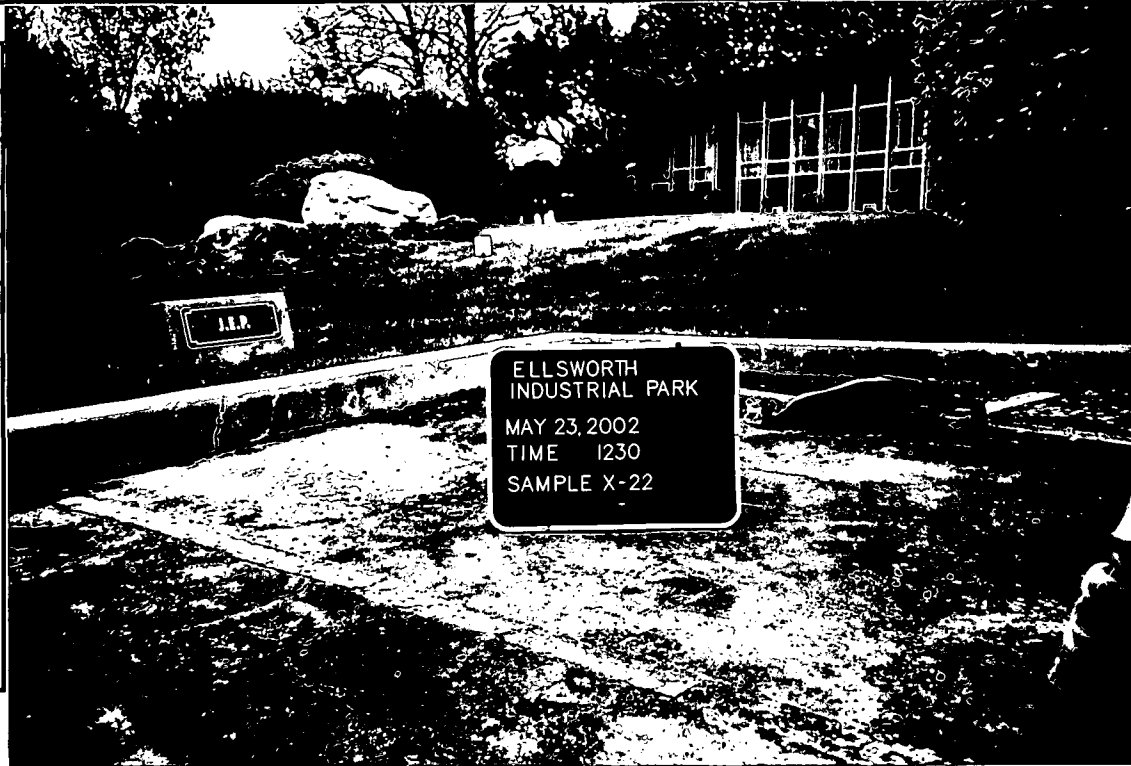
**PHOTO:** Roll 2 / Photo 15

**COMMENTS:** Photo of soil sample location X-22, collected from probe location GP-22. Located in the north parking lot of the Arrow Gear Co. facility located at 2301 Curtiss Street.

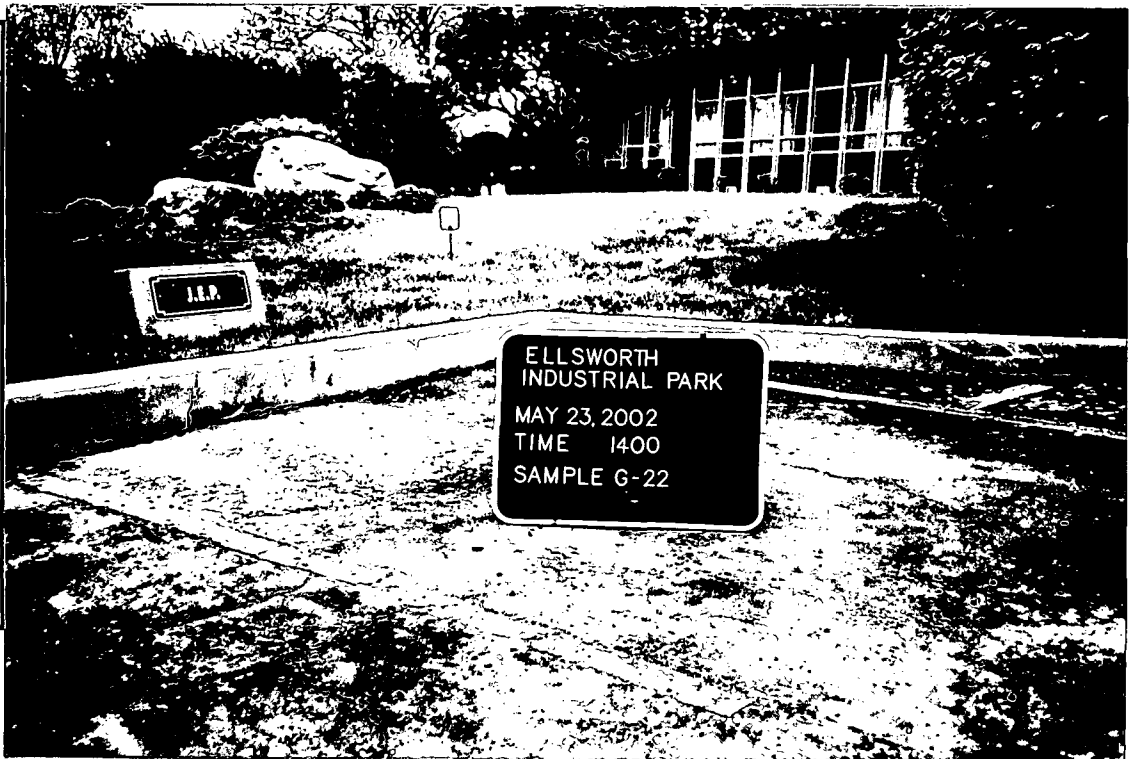
**PHOTO:** Roll 2 / Photo 16

**COMMENTS:** Photo of groundwater sample location G-22, collected from probe location GP-22. Located in the north parking lot of the Arrow Gear Co. facility located at 2301 Curtiss Street.

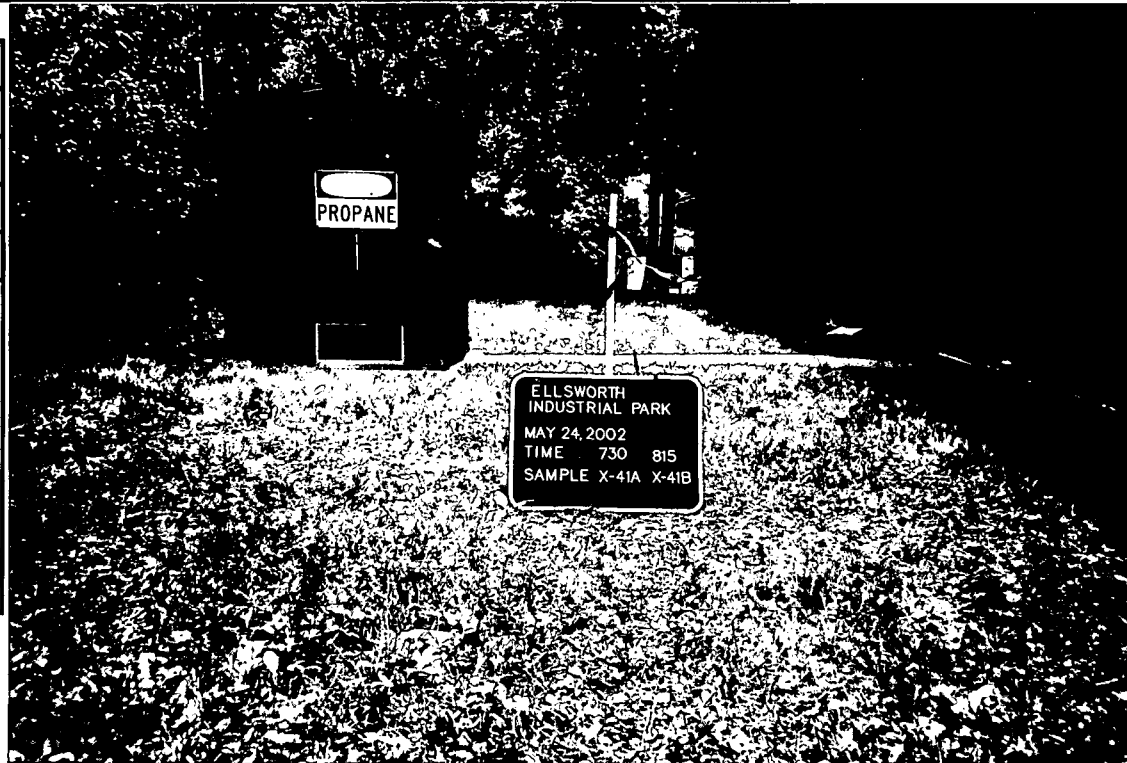
**COMMENTS:** Photo of soil sample location X-41A and X-41B, collected from probe location GP-41. Located west of the Ames Supply Co. at 2537 Curtiss Street.

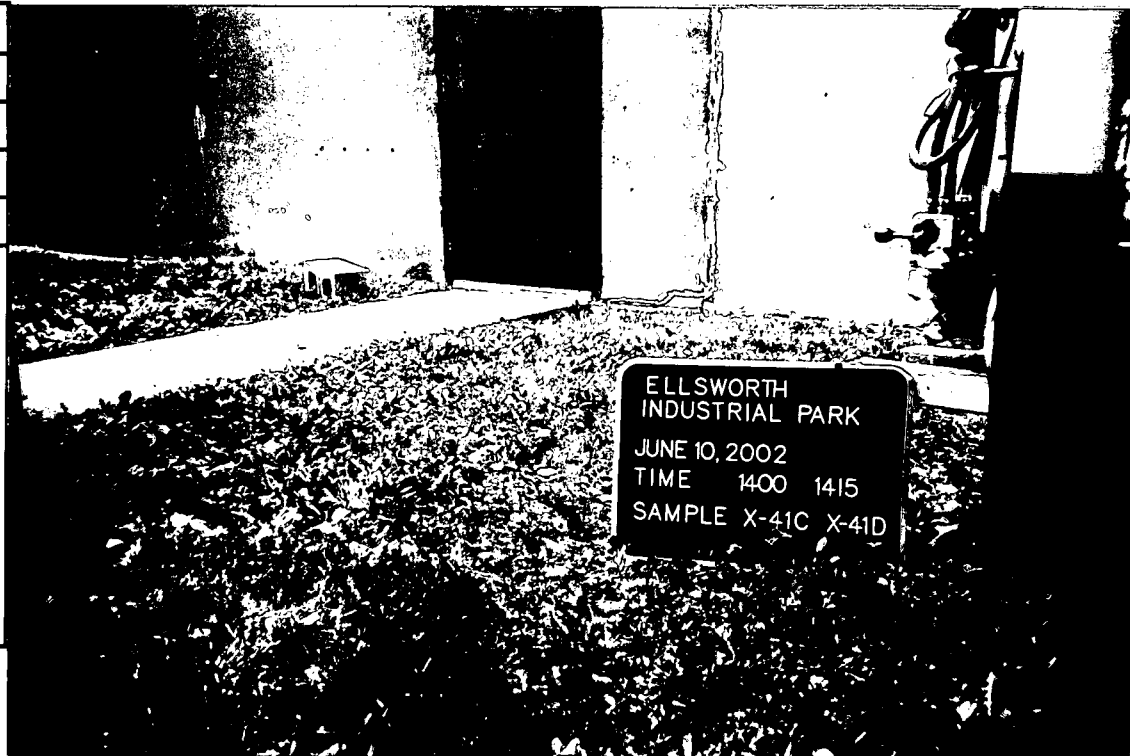
**COMMENTS:** Photo of soil sample location X-41C and X-41D, collected from probe location GP-41. Located west of the Ames Supply Co. at 2537 Curtiss Street.

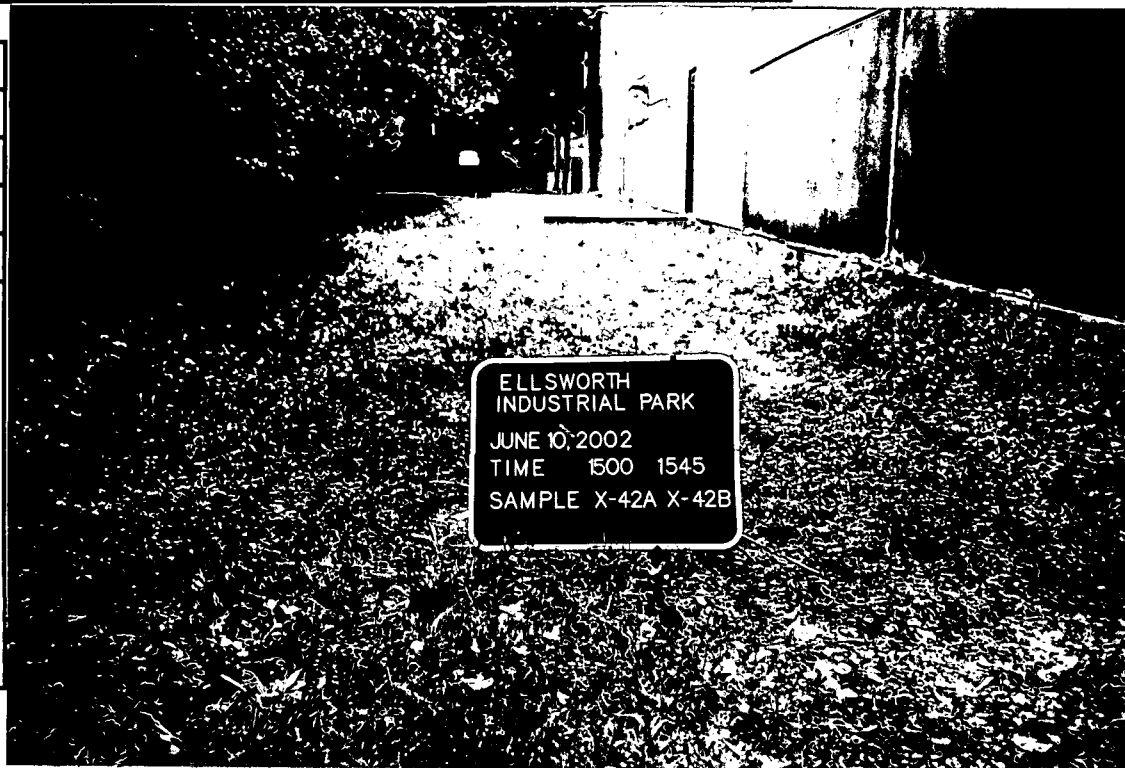
**COMMENTS:** Photo of soil sample location X-42A and X-42B, collected from probe location GP-42. Located west of the Ames Supply Co. at 2537 Curtiss Street.

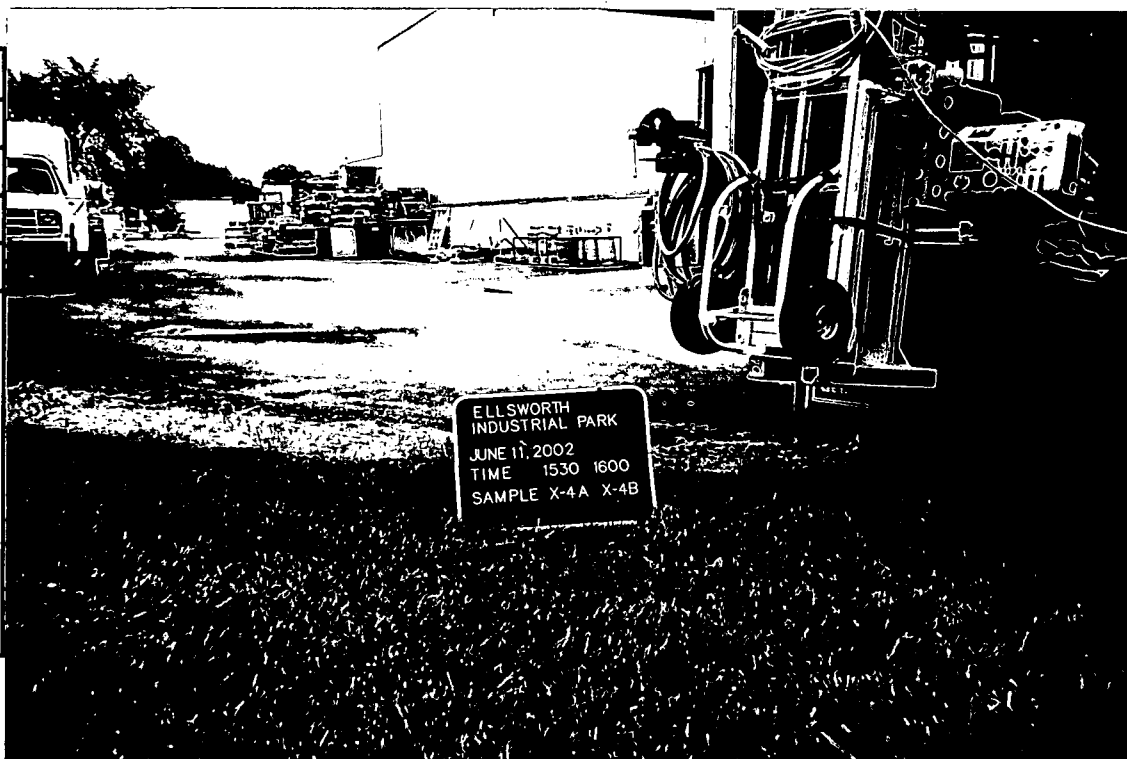
**COMMENTS:** Photo of soil sample location X-4A and X-4B, collected from probe location GP-4. Located north of the Rexnord Corporation facility at 2400 Curtiss Street.

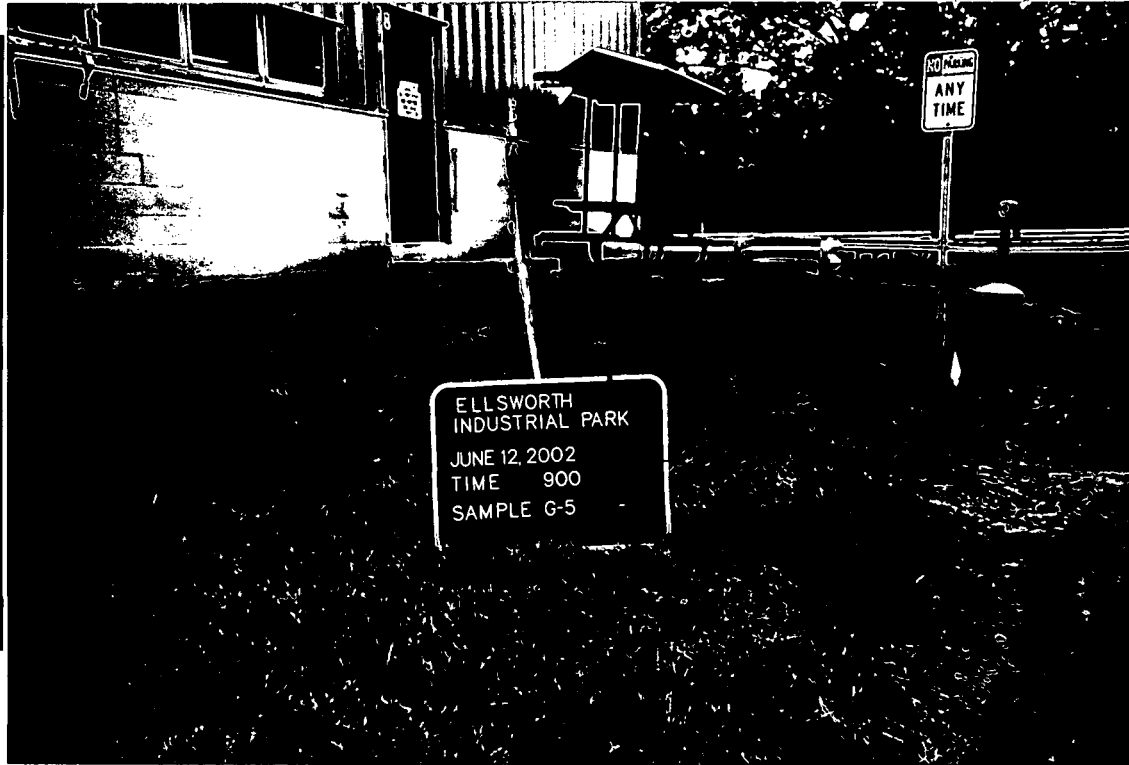
**COMMENTS:** : Photo of groundwater sample location G-5, collected from probe location GP-5. Located west of the Rexnord Corporation facility at 2400 Curtiss Street.

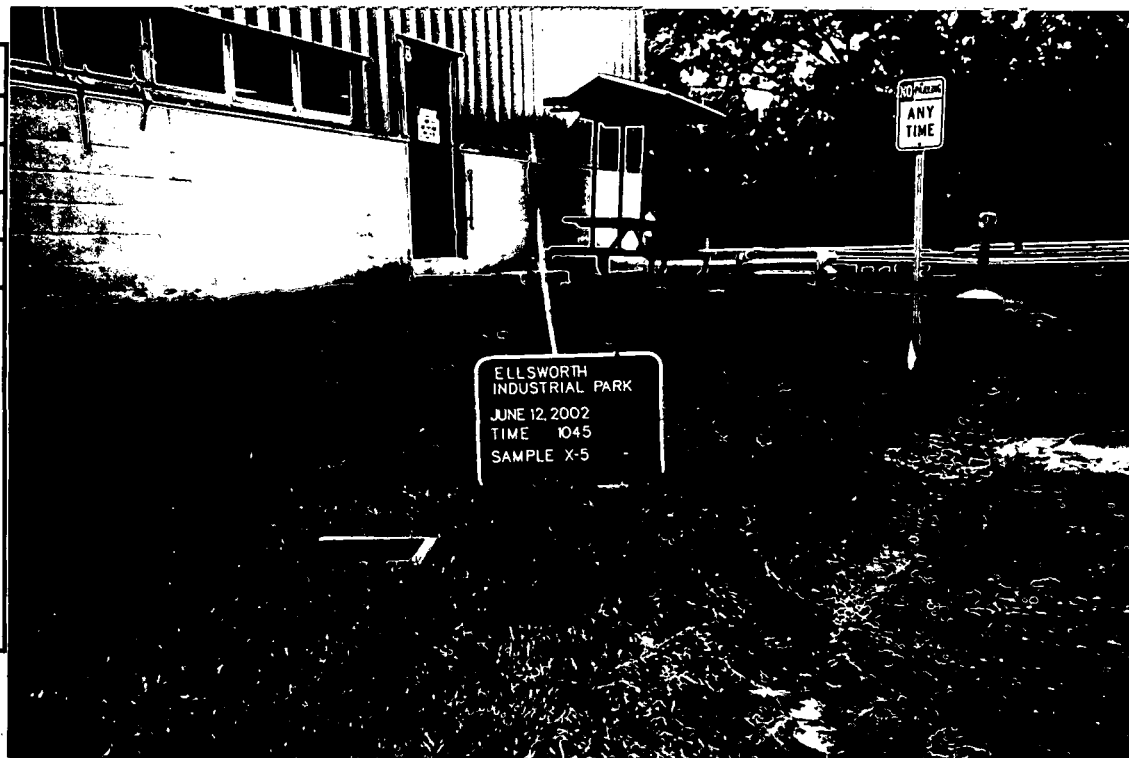
**COMMENTS:** Photo of soil sample location X-5, collected from probe location GP-5. Located west of the Rexnord Corporation facility at 2400 Curtiss Street.

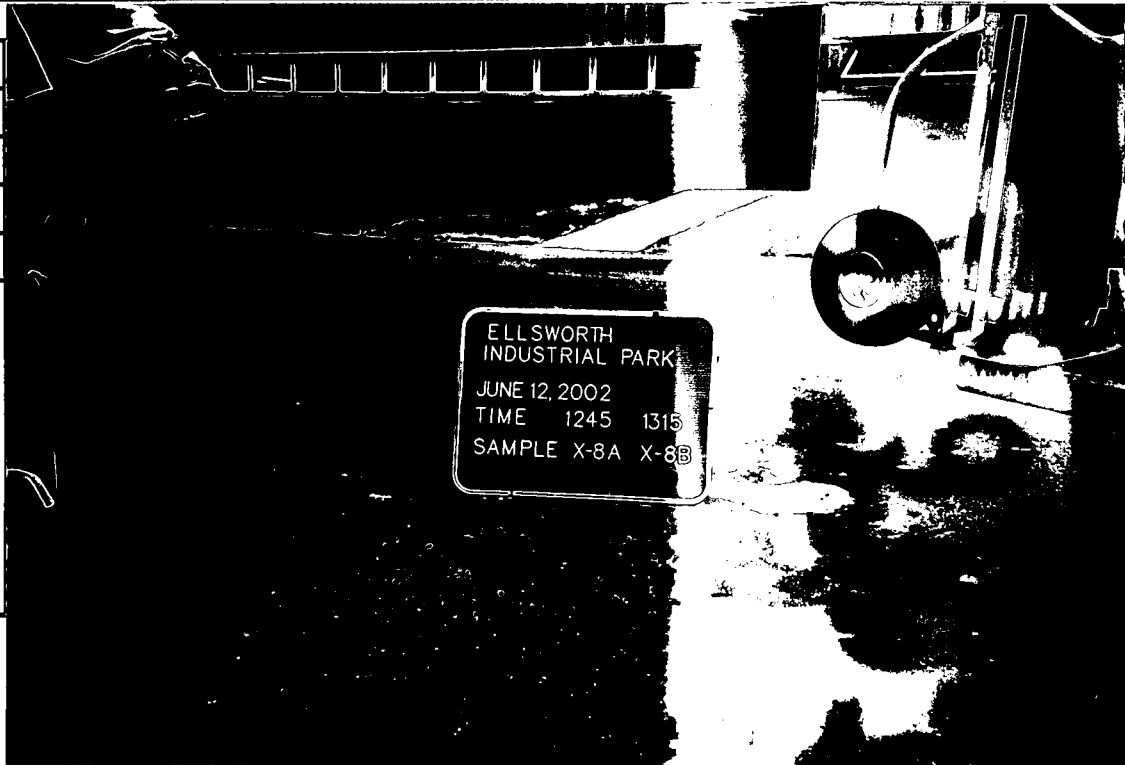
**COMMENTS:** Photo of soil sample location X-8A and X-8B, collected from probe location GP-8. Located south of the Rexnord Corporation facility at 2400 Curtiss Street.

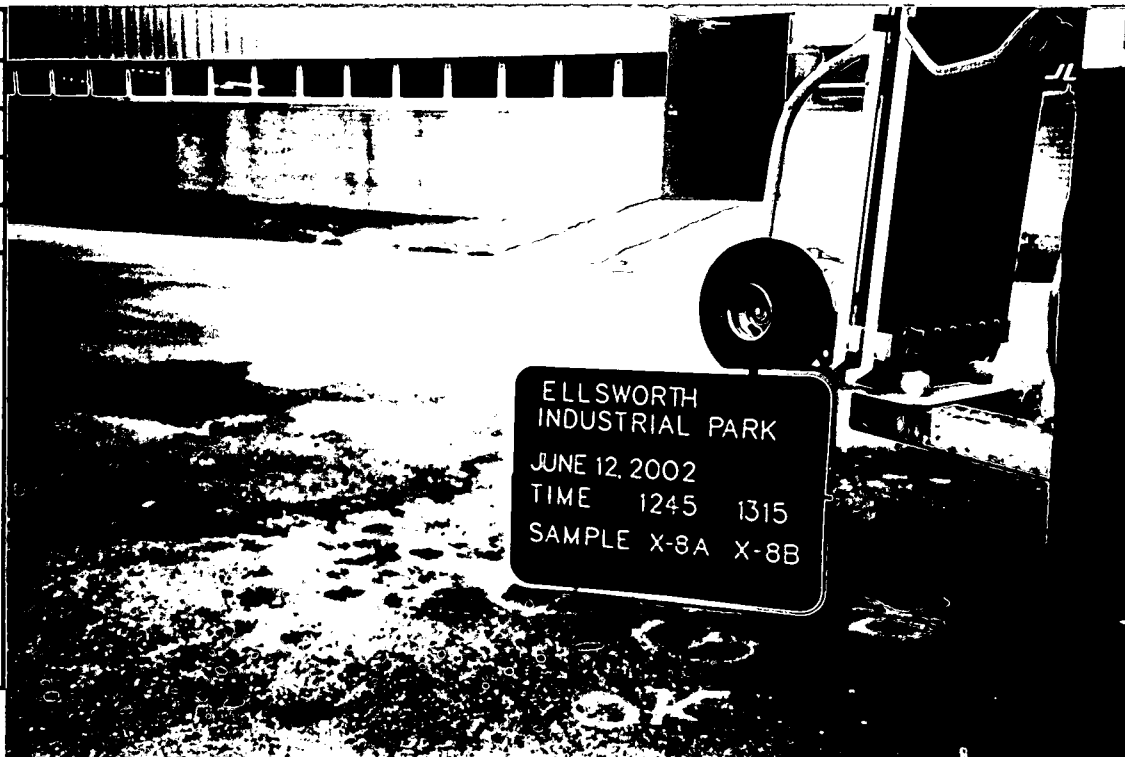
**COMMENTS:** Photo of soil sample location X-8A and X-8B, collected from probe location GP-8. Located south of the Rexnord Corporation facility at 2400 Curtiss Street.

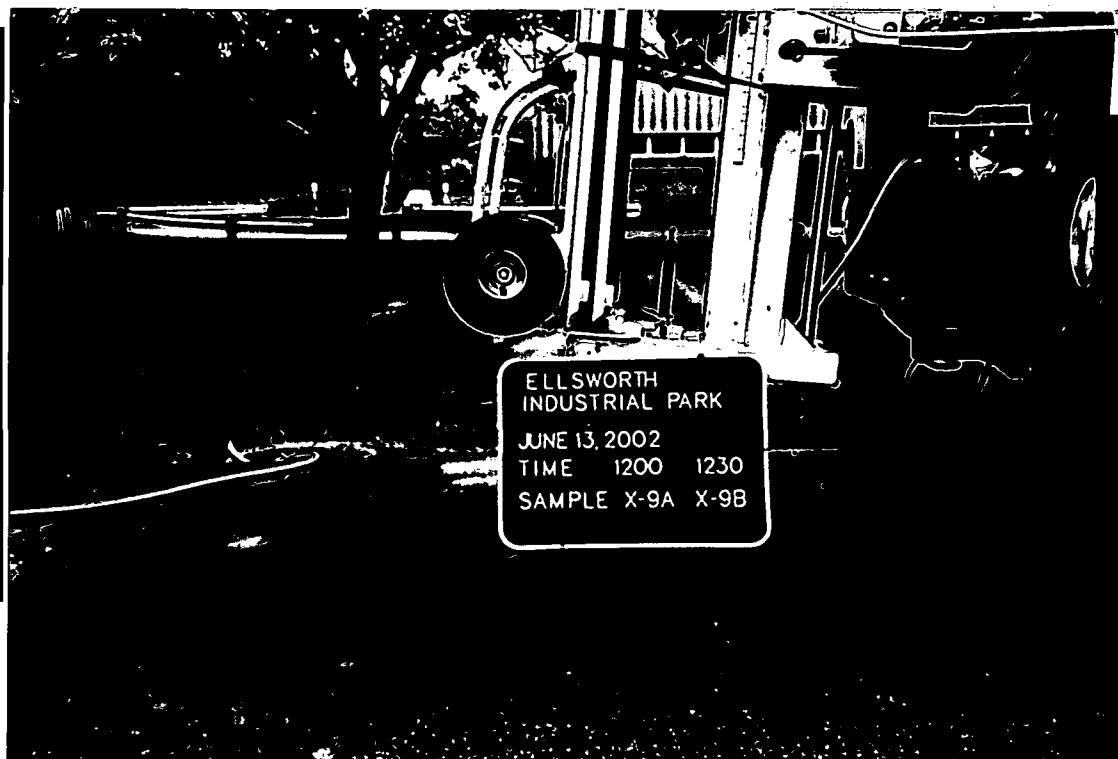
**COMMENTS:** Photo of soil sample location X-9A and X-9B, collected from probe location GP-9. Located south of the Rexnord Corporation facility at 2400 Curtiss Street.

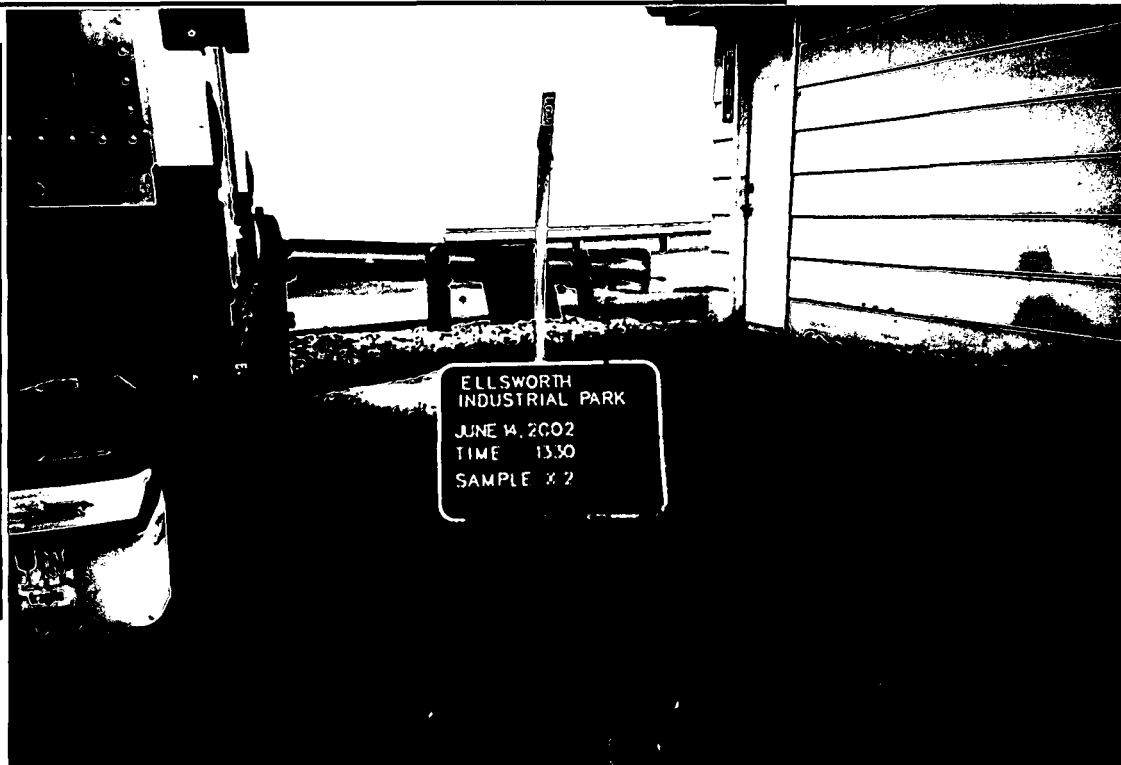
**COMMENTS:** Photo of soil sample location X-2, collected from probe location GP-2. Located north of the Rexnord Corporation facility at 2400 Curtiss Street.

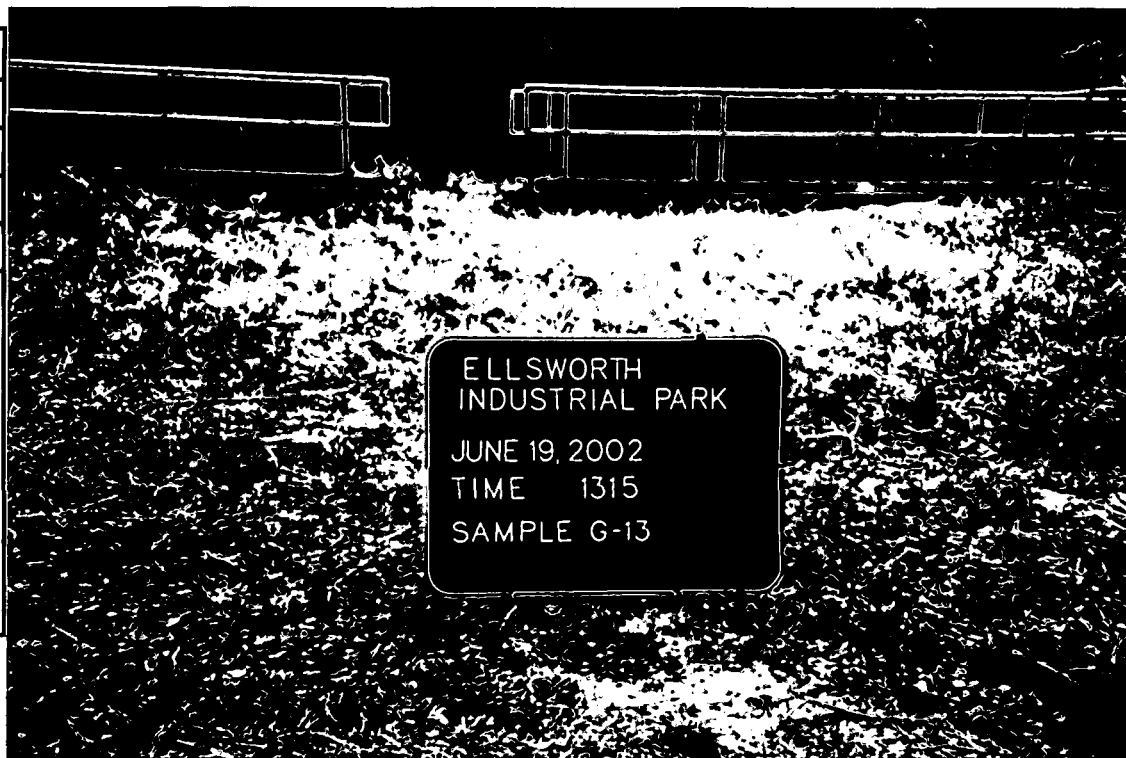
**COMMENTS:** Photo of groundwater sample location G-13, collected from probe location GP-13. Located north of the Sanitary District's settlement pond north of Curtiss Street and west of Dyna Gear.

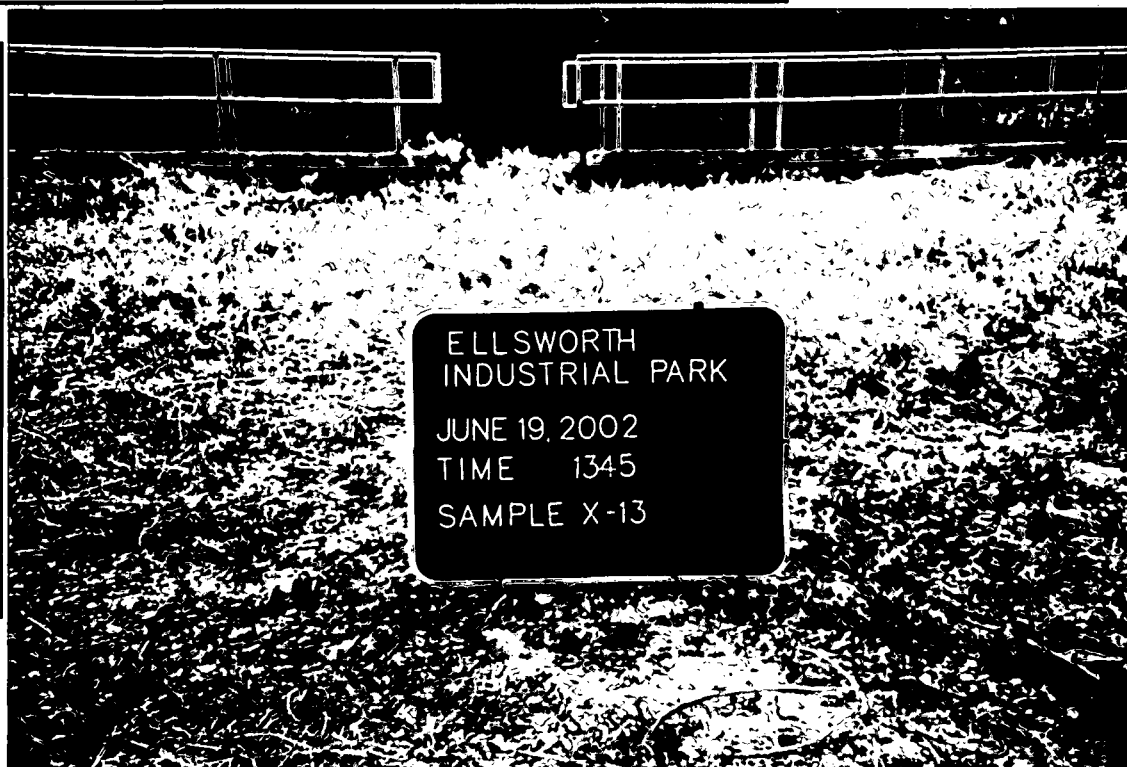
**COMMENTS:** Photo of soil sample location X-13, collected from probe location GP-13. Located north of the Sanitary District's settlement pond north of Curtiss Street and west of Dyna Gear.
